Memorandum

Date: *August 15, 2014*

Subject: *Oversight Summary Report
CPG Oversight of RM 10.9 Removal Action
Lower Passaic River Restoration Project*

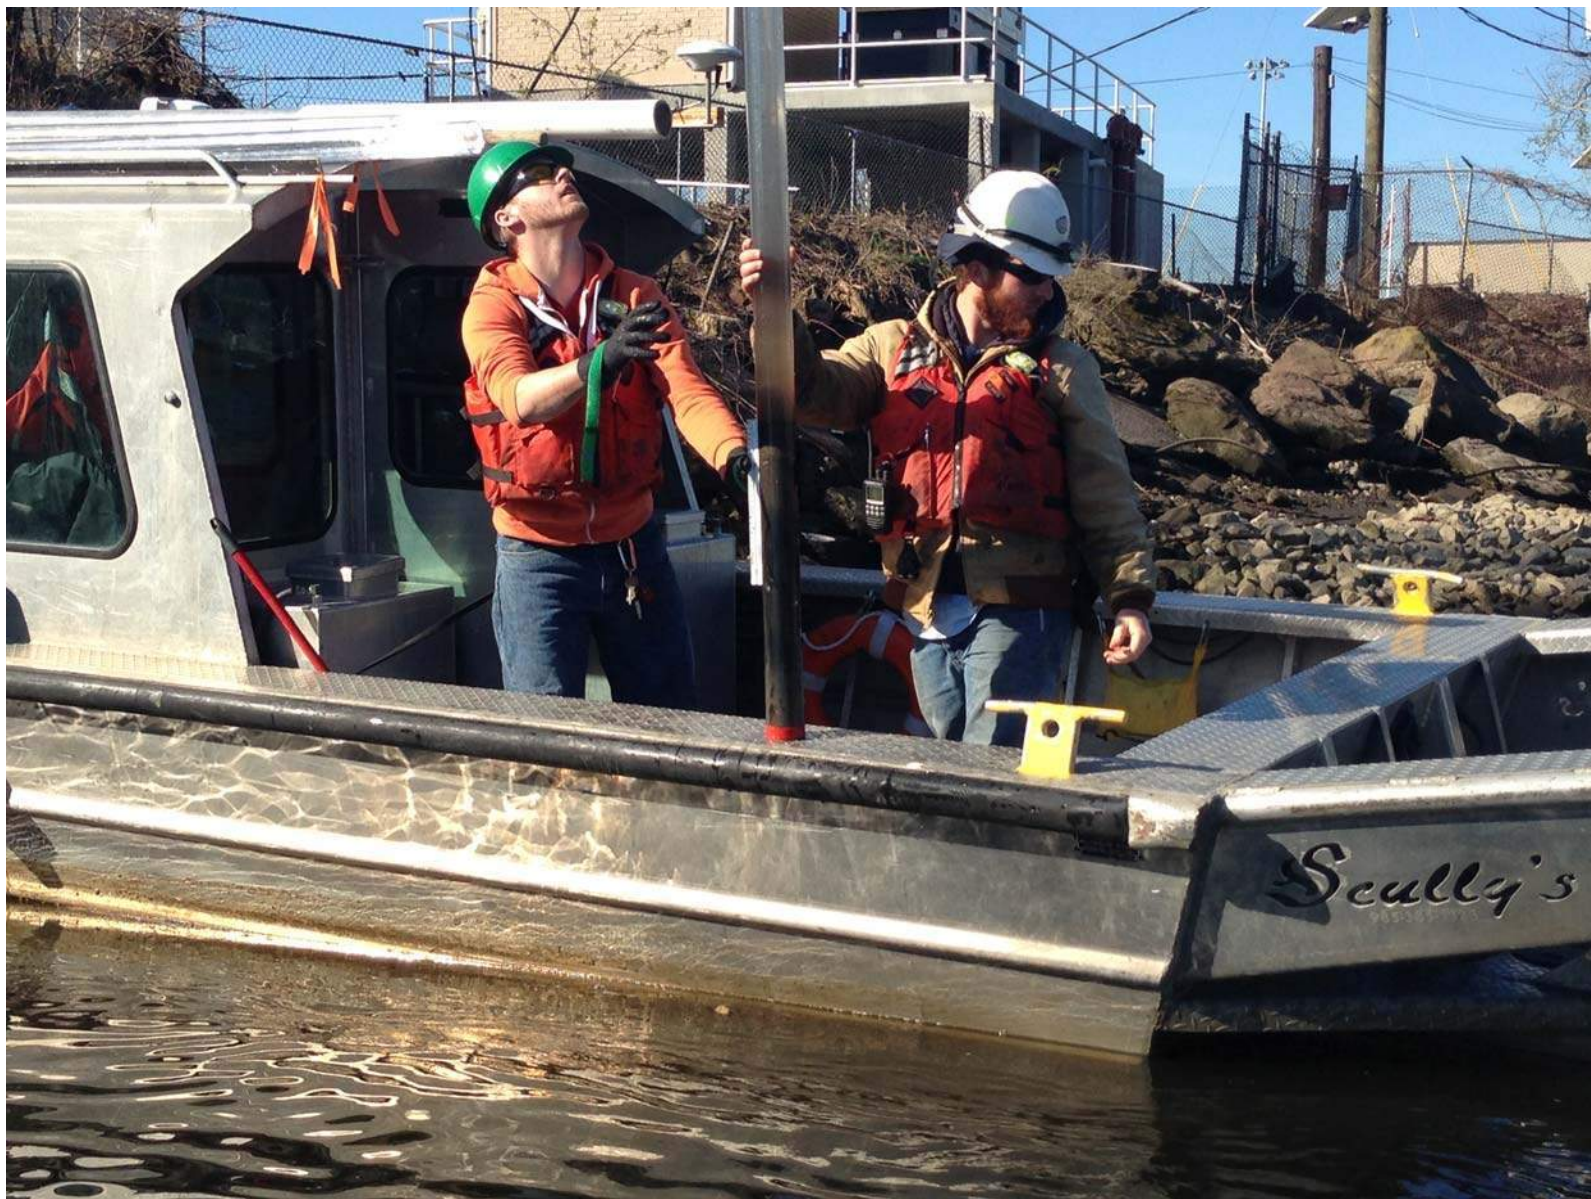
Active Layer Core Collected from 37-N

GLDD collected a sediment core from the 37-N area. The core contained approximately 9 inches of sand/AquaGate.

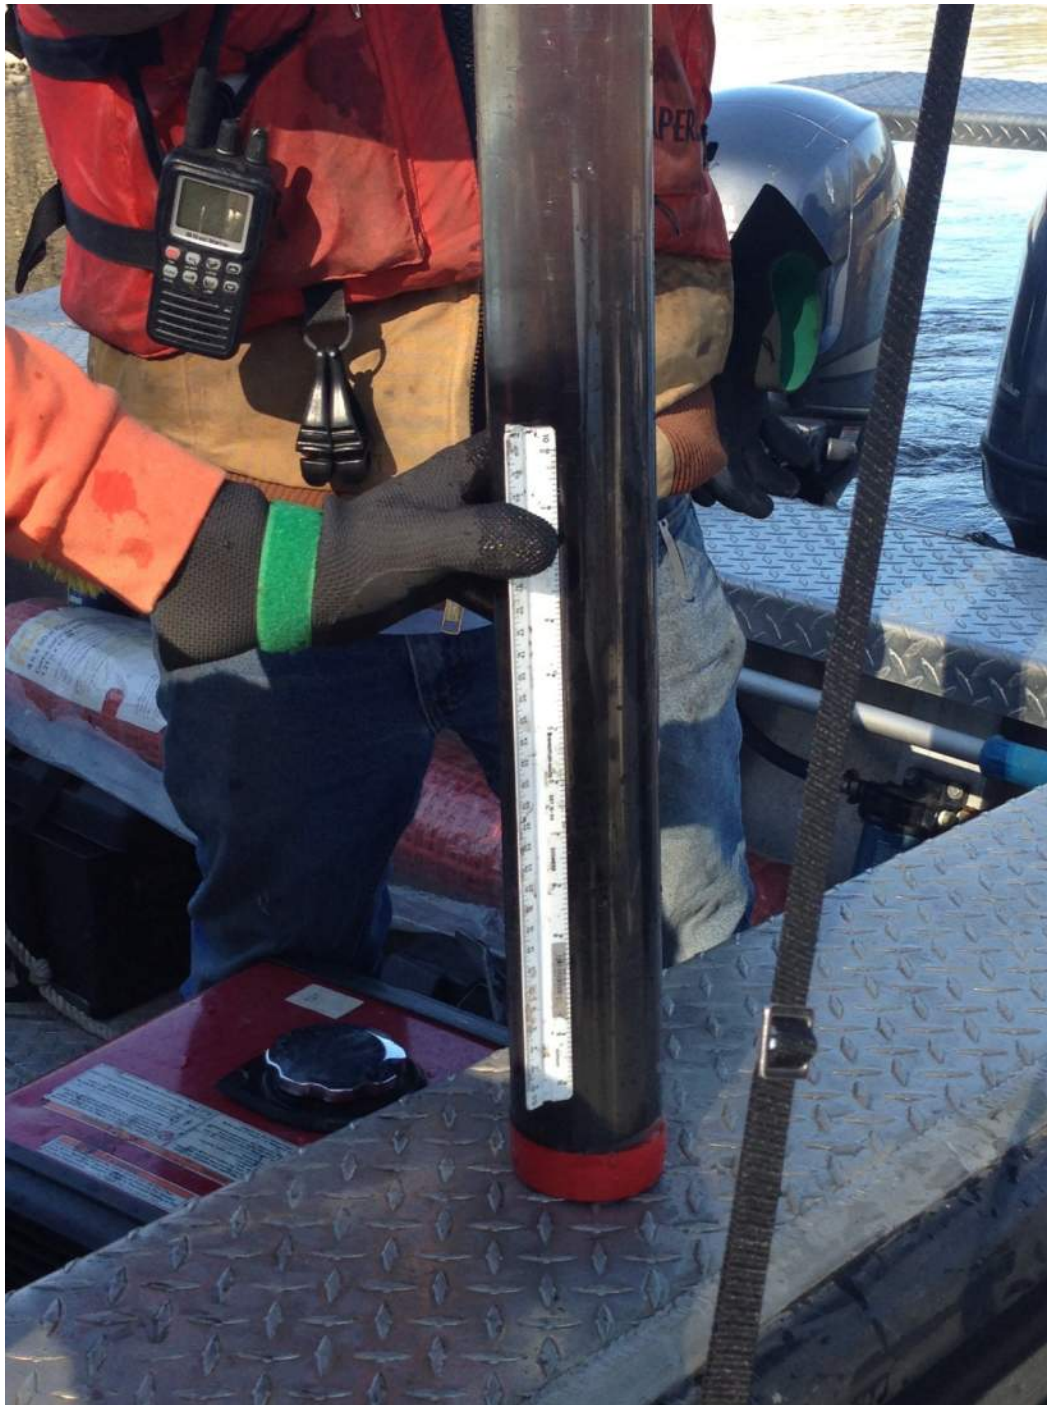
Core Collected from 39-N

GLDD collected a sediment core from the 39-N area. The core contained approximately 10 inches of sand/AquaGate.

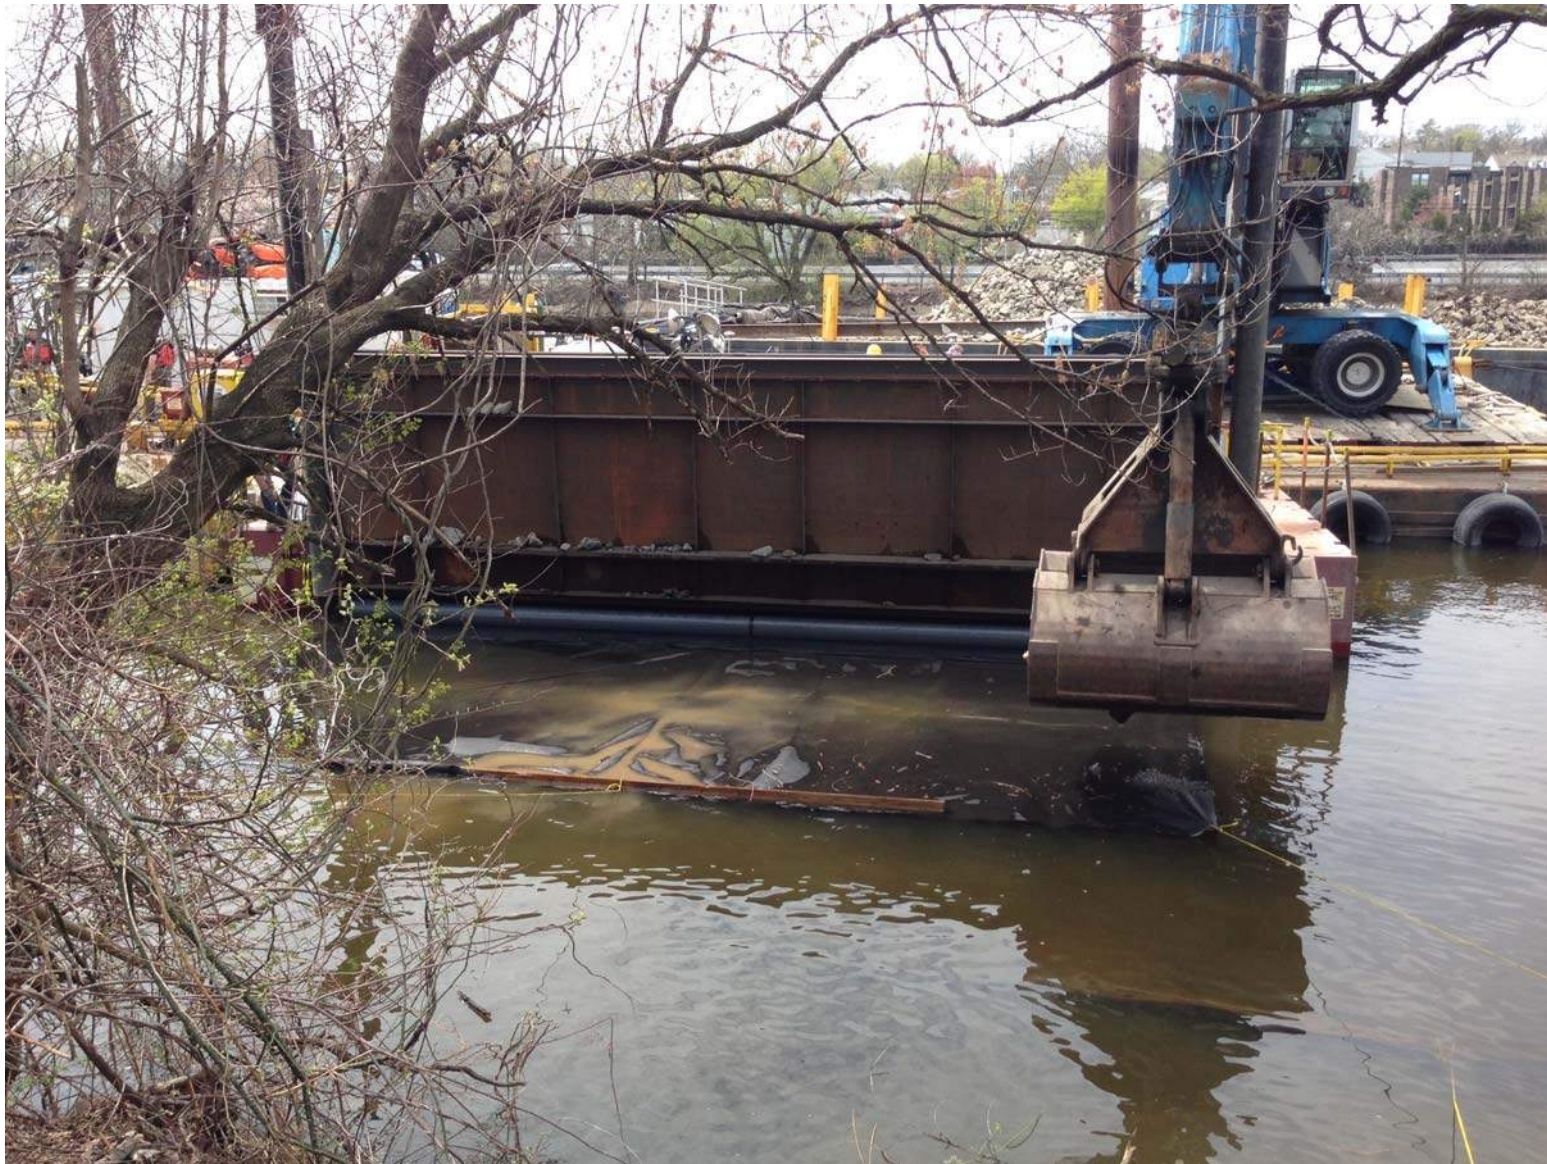
Installation of Panel 8-S

GLDD installed four geotextile panels in the afternoon. Sufficient overlap was observed between adjacent panels.

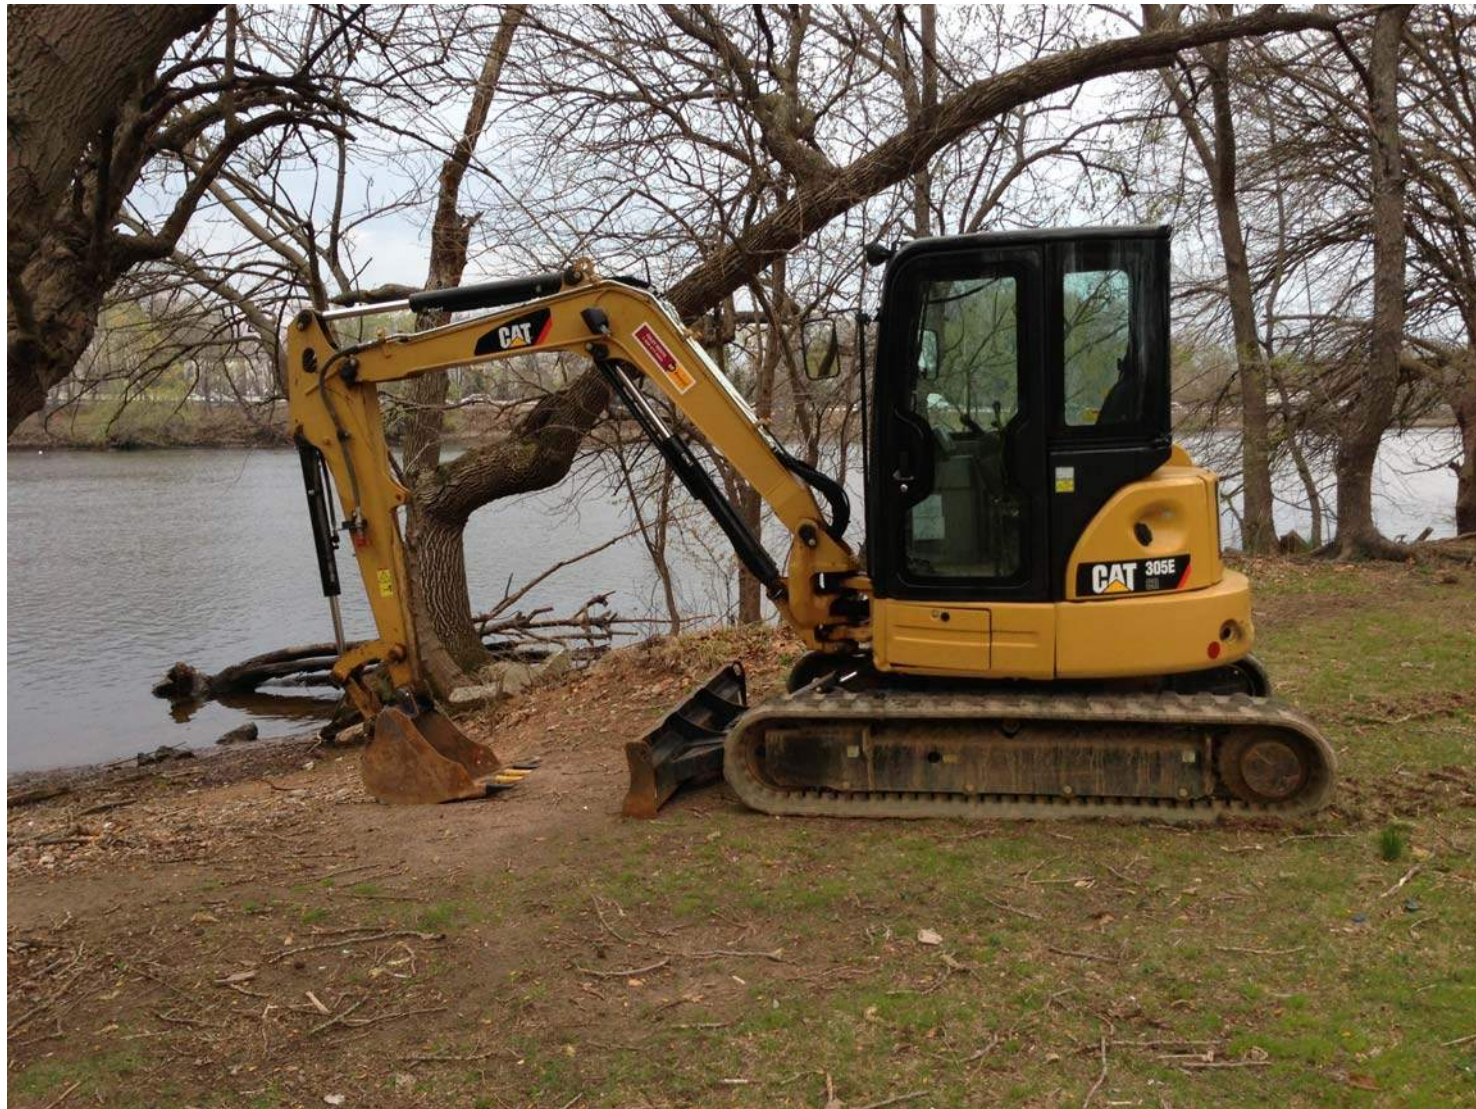
Track-Mounted Mini Excavator

Shown above is the machine that GLDD will drive onto the geotextile fabric south of the No Dredge Zone to even out high spots prior to the armor stone thickness survey. This activity will commence in the morning on April 23rd at low tide.

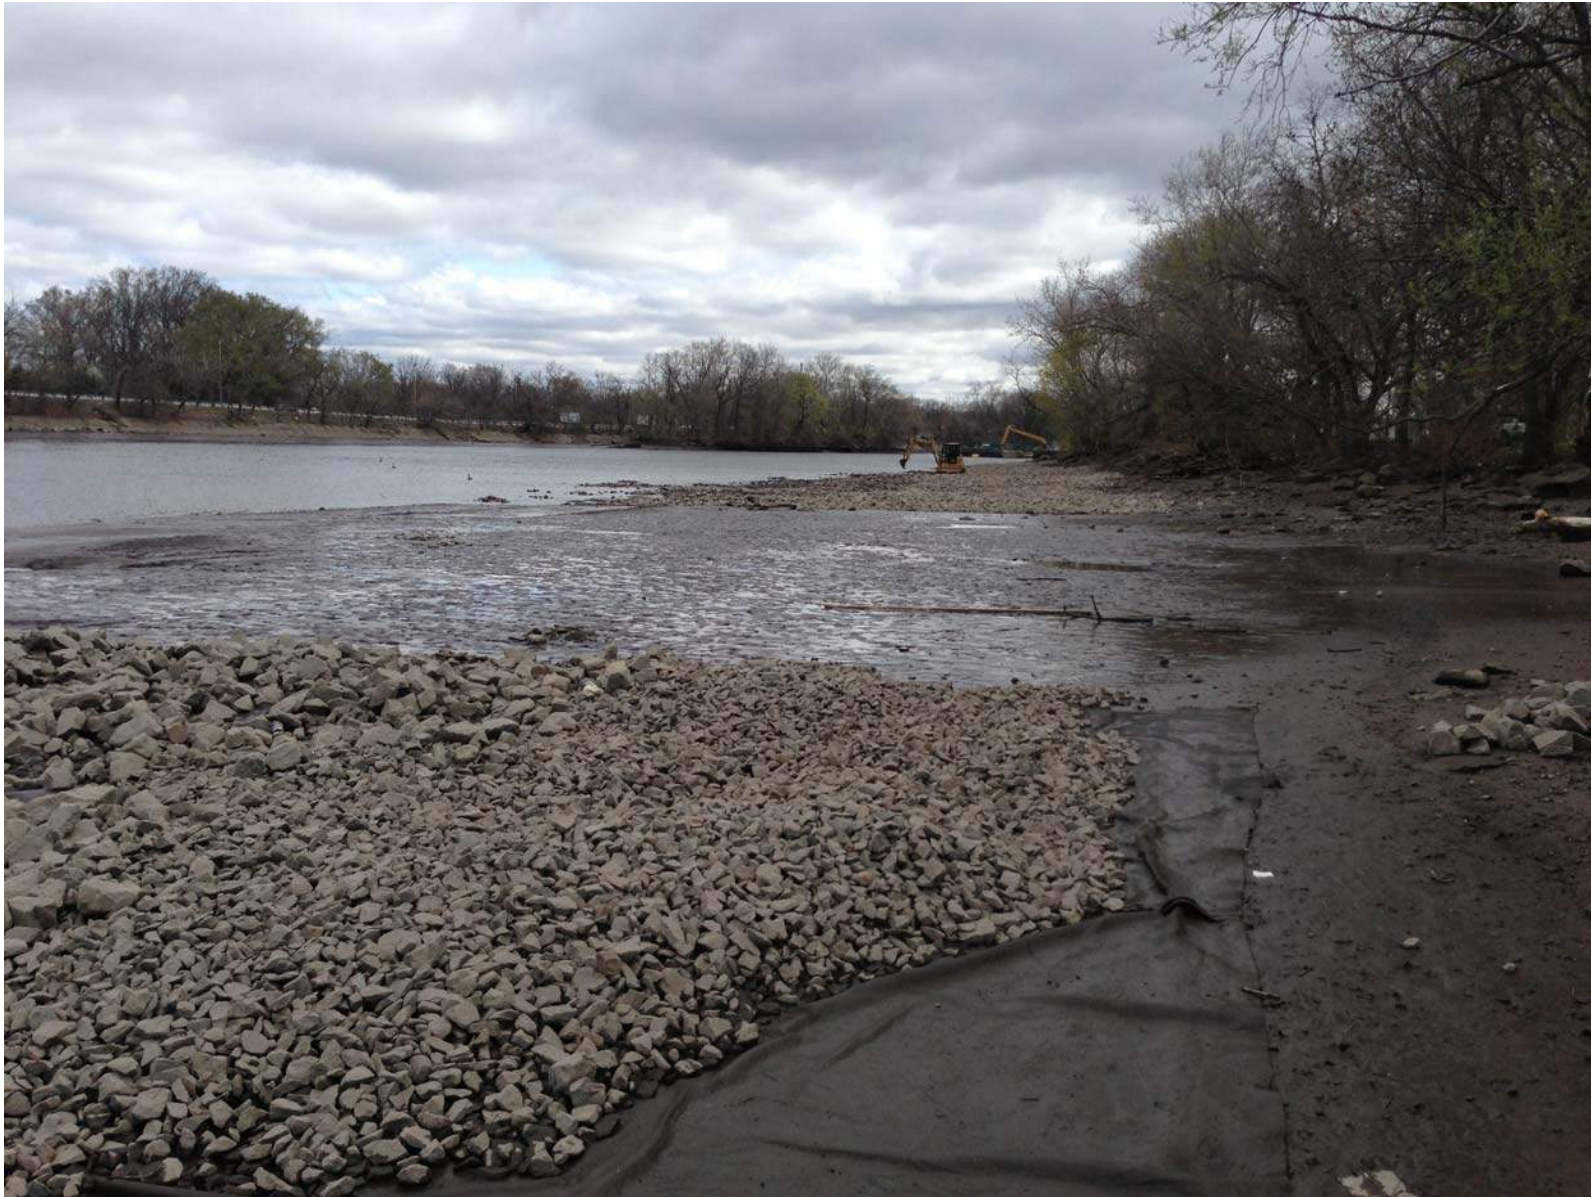
Exposed Armor Stone at Low Tide

The mini excavator is shown leveling out armor stone north of the No Dredge Zone. Type B stone, immediately south of the No Dredge Zone, is shown in the foreground of the photograph.

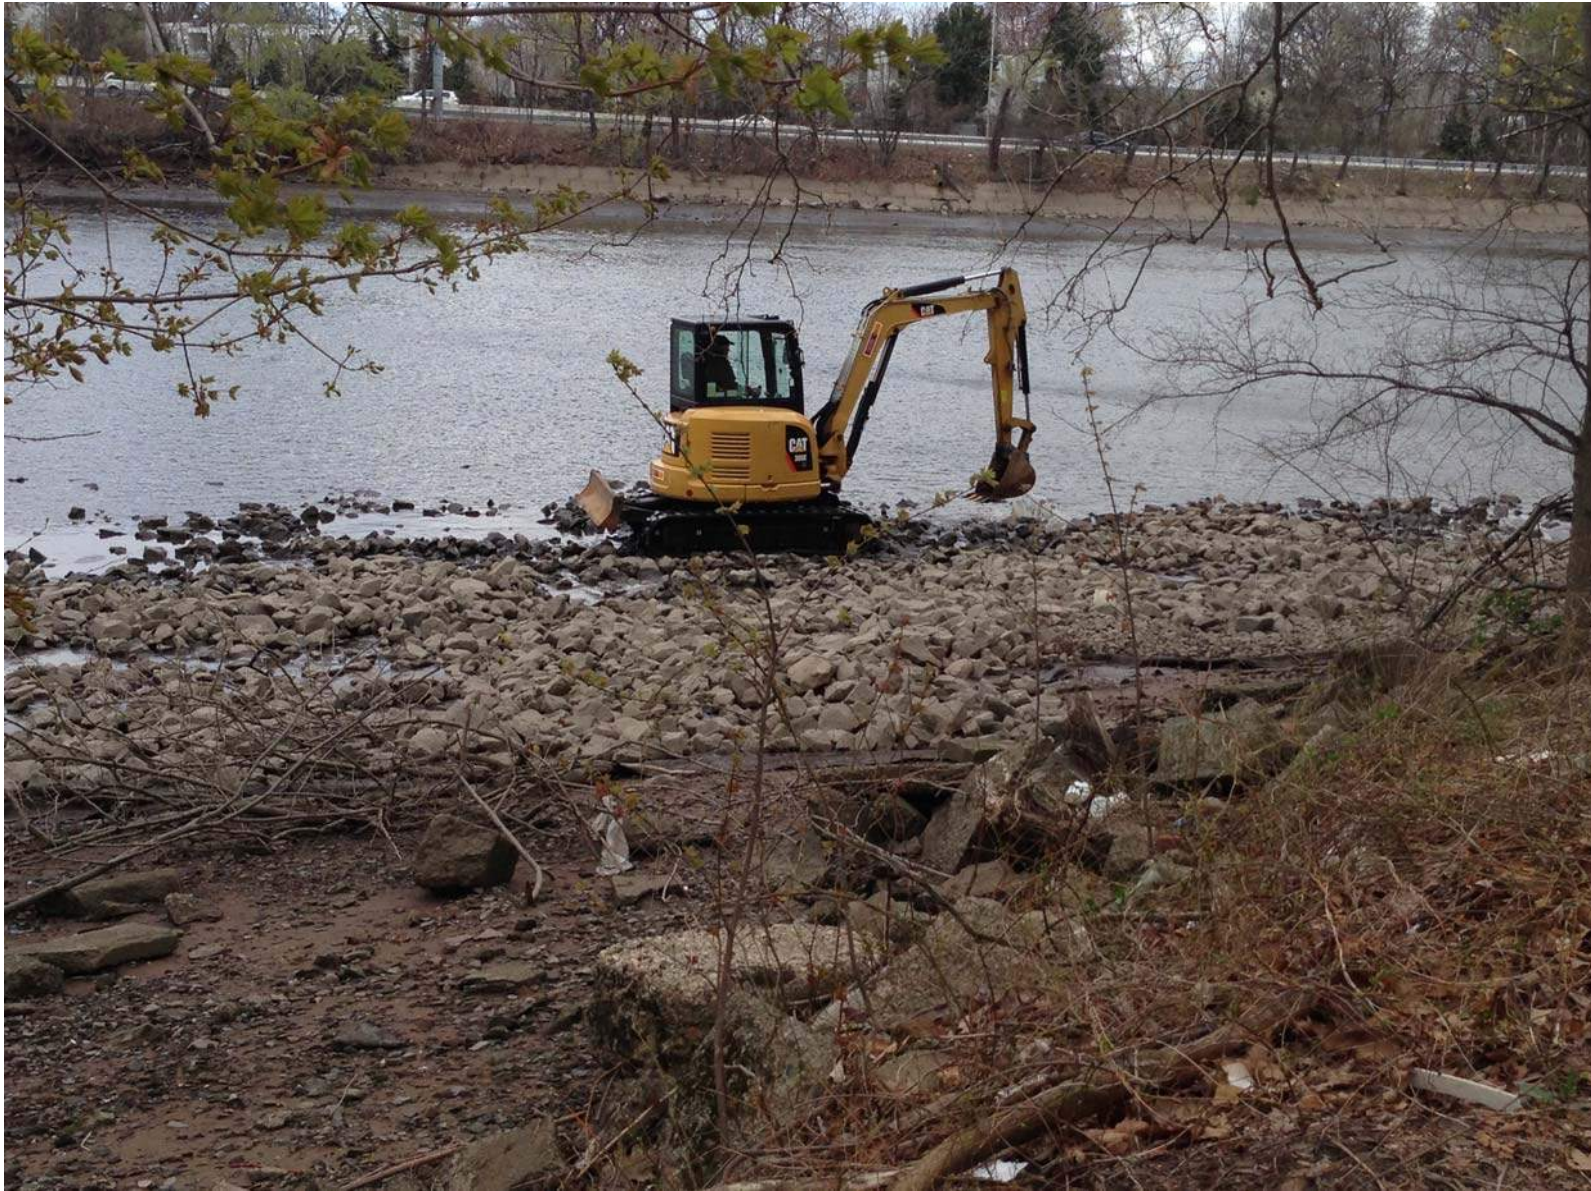
Track-Mounted Mini Excavator

The CAT 402E mini excavator is shown moving armor stone from high points to low points.

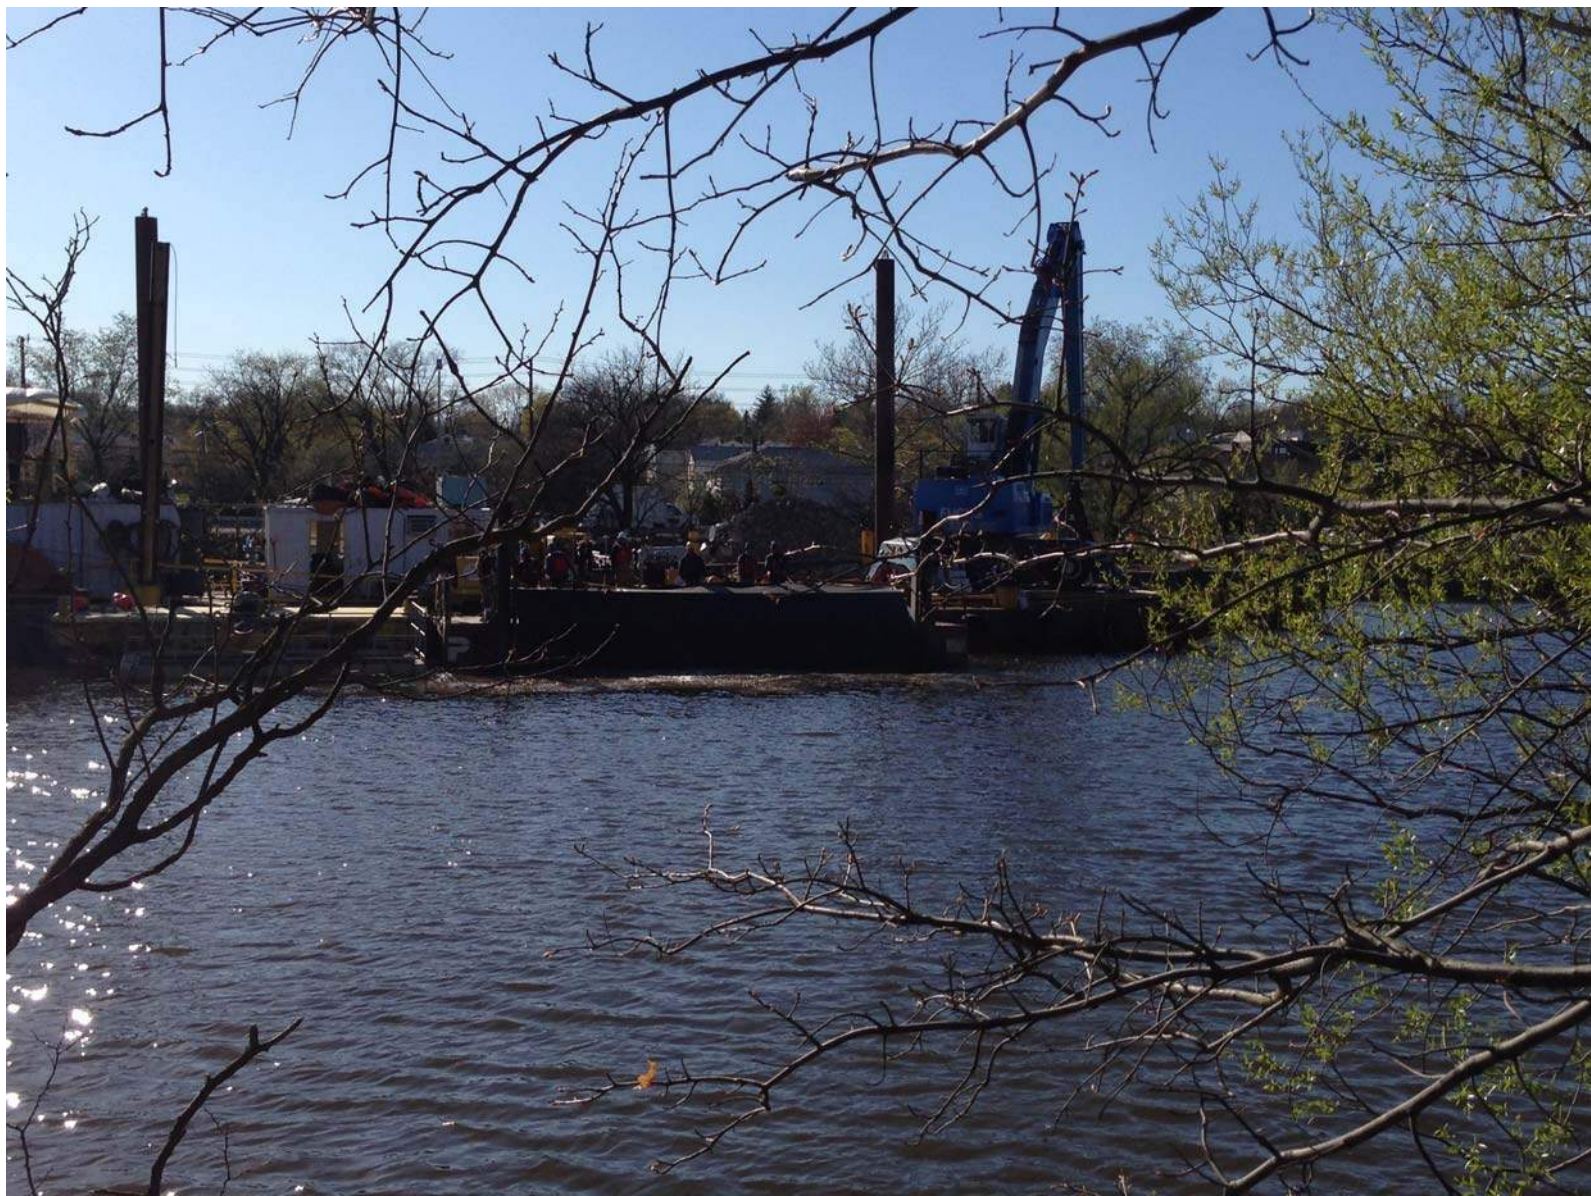
Geotextile Panel 1-S Installation

The southernmost panel in the capping area was installed at high tide. Sufficient overlap was observed with adjacent panel 2-S.

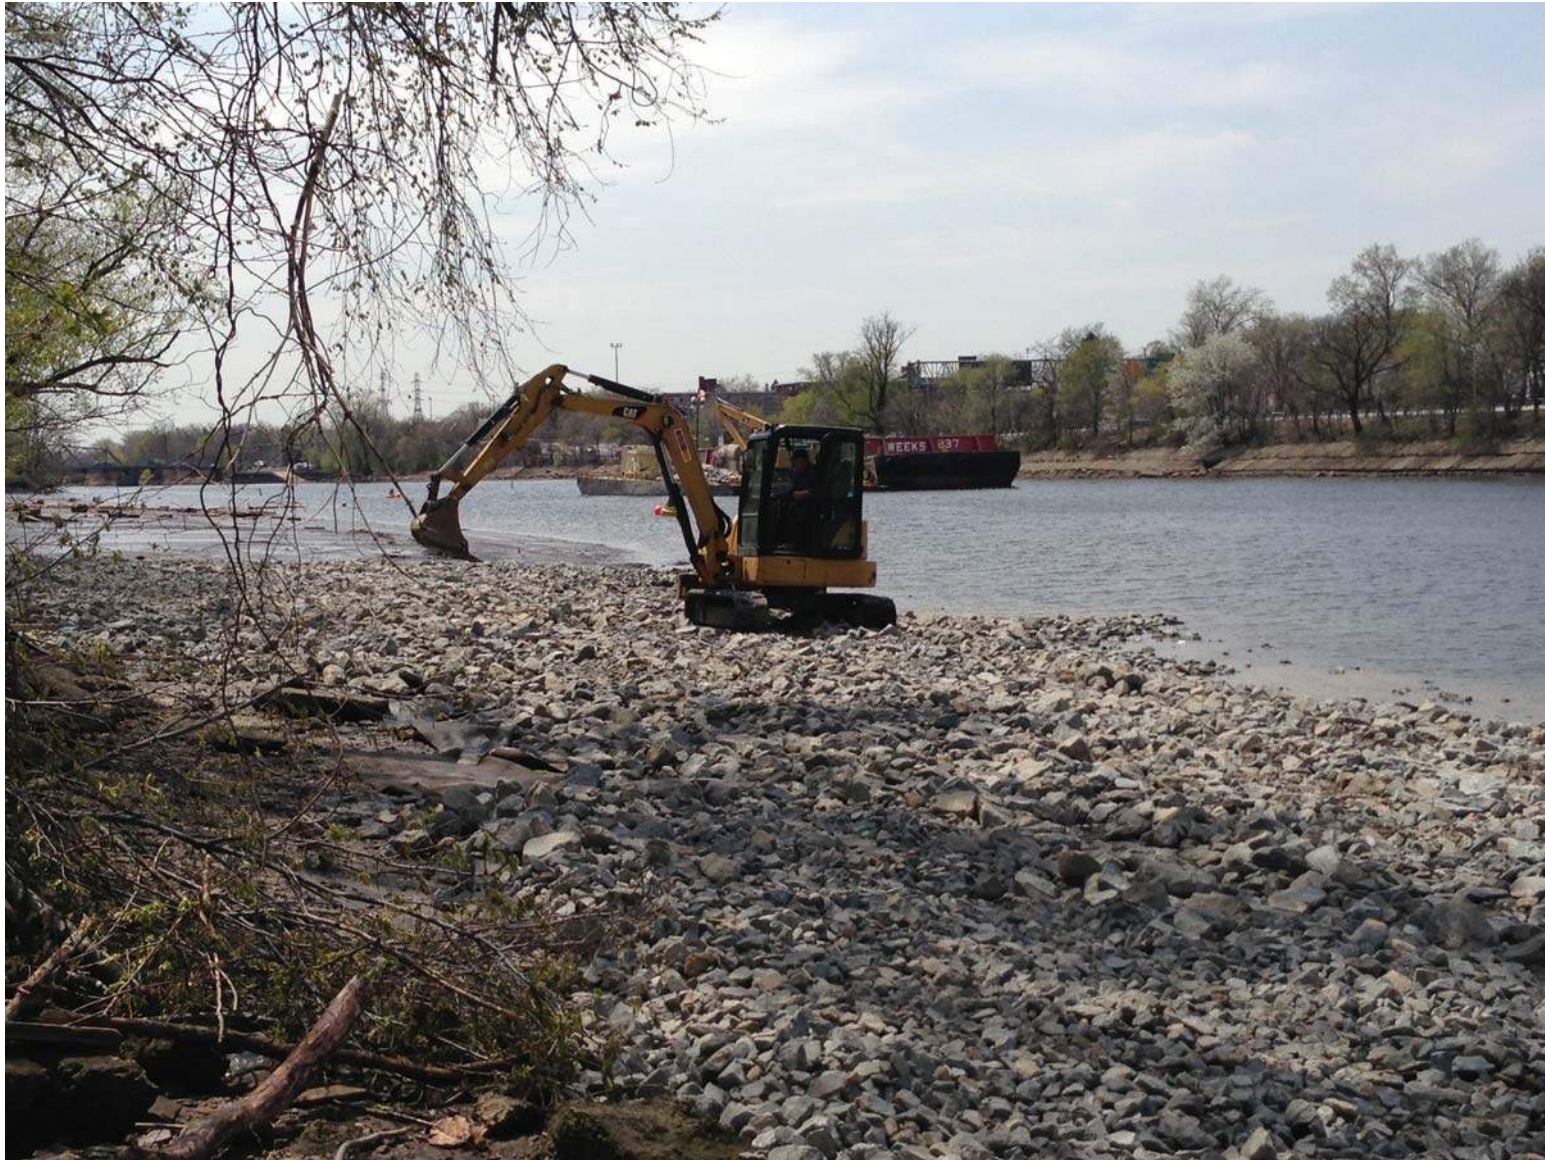
Armor Stone Leveling

GLDD continued leveling the armor stone near the shore. Part of the reason for this activity is that, with the armor stone placed, it will be difficult to get the barge close to shore to fill in low spots.

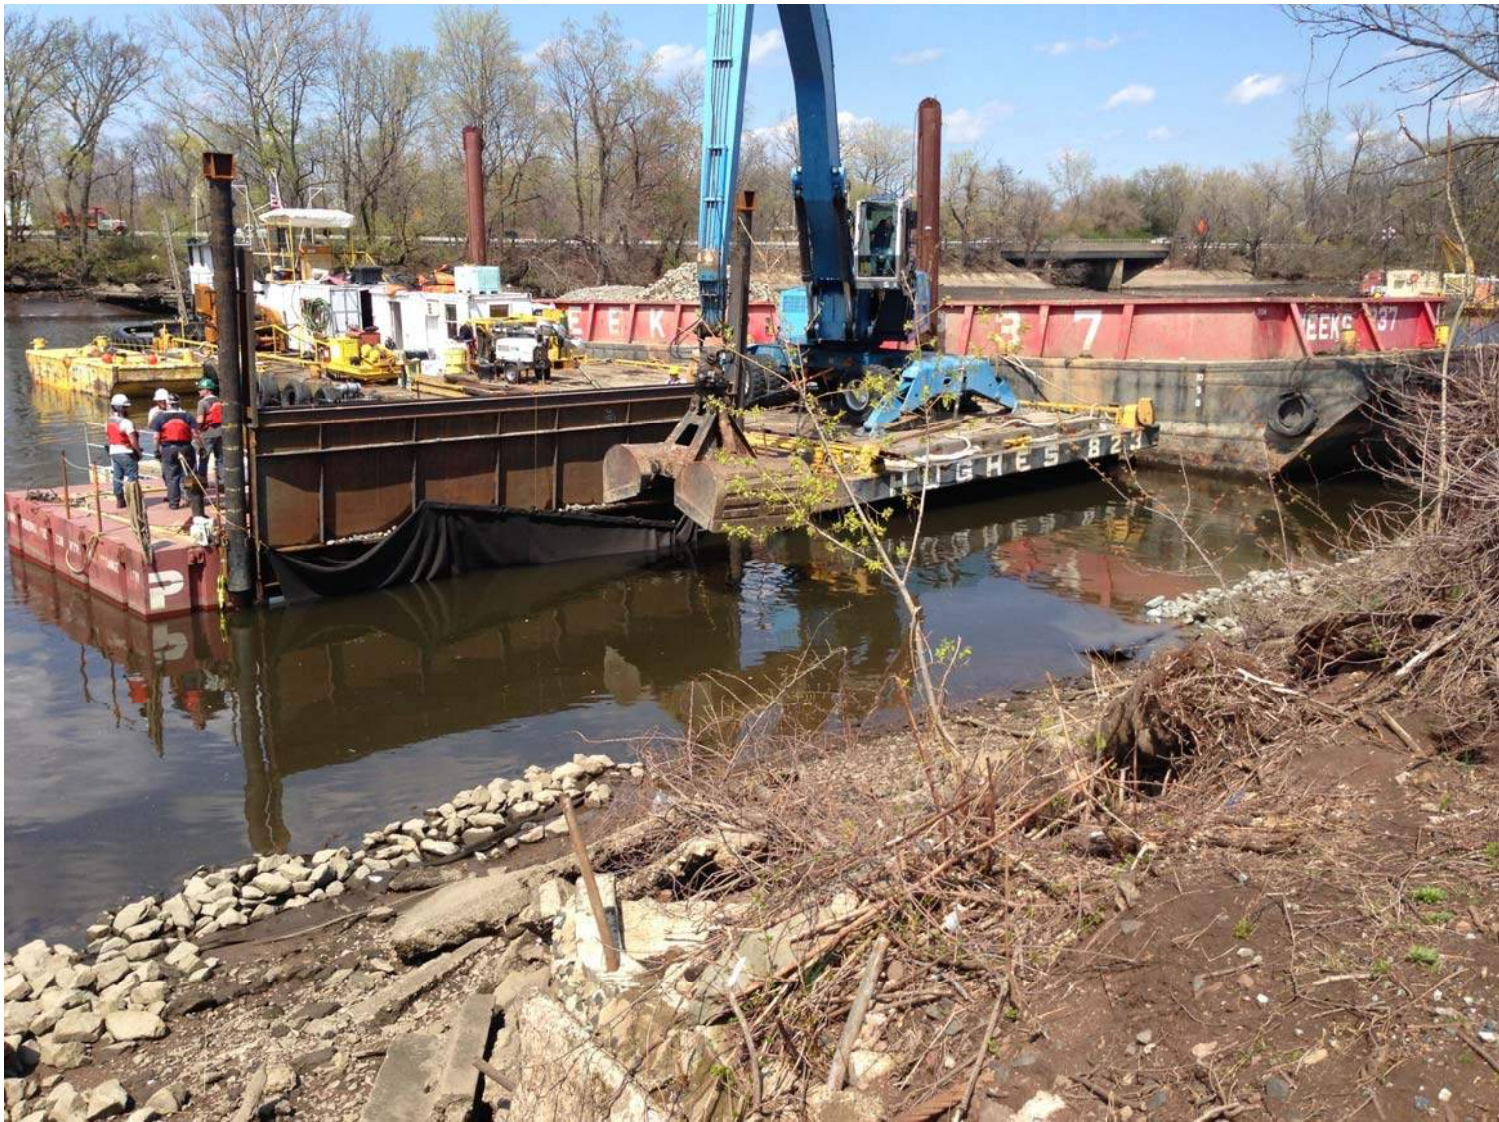
Geotextile Panel 37-N Installation

GLDD installed panel 37-N, the final panel in the capping area, between existing panels 36-N and 38-N.

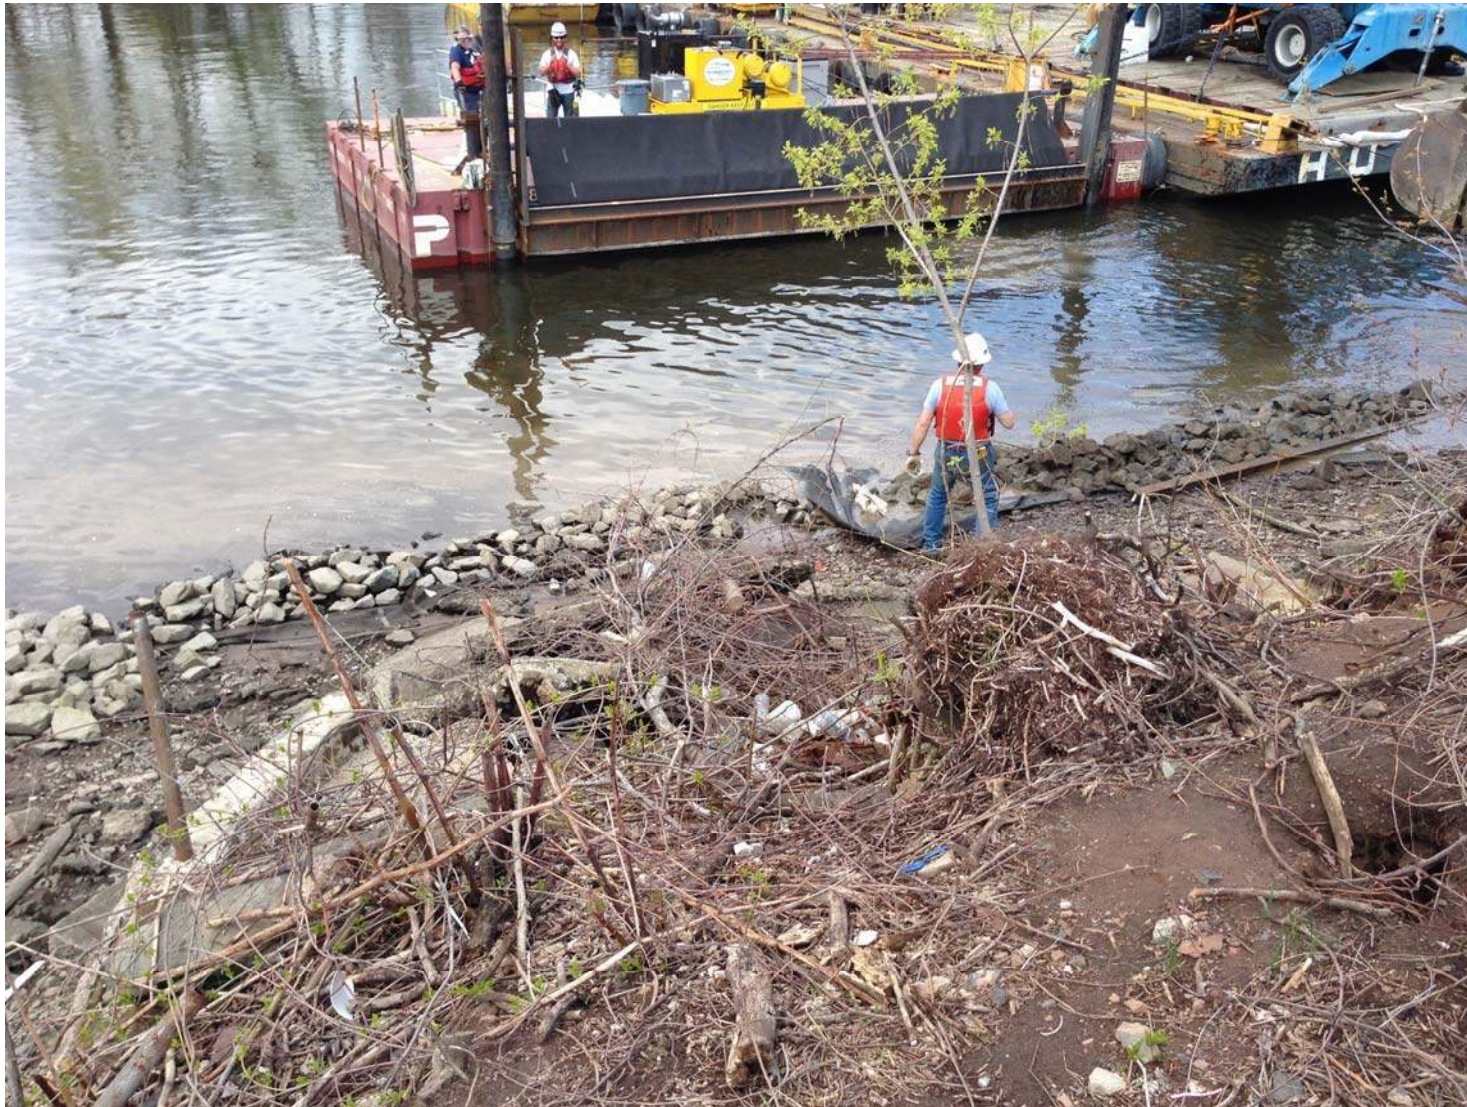
Geotextile Panel 37-N Installation

GLDD measured 20 inches of overlap with adjacent panel 36-N. Armor stone was not placed on the overlapping segment. In the photograph above, a white sand bag is placed to show where the operator should not place armor stone.

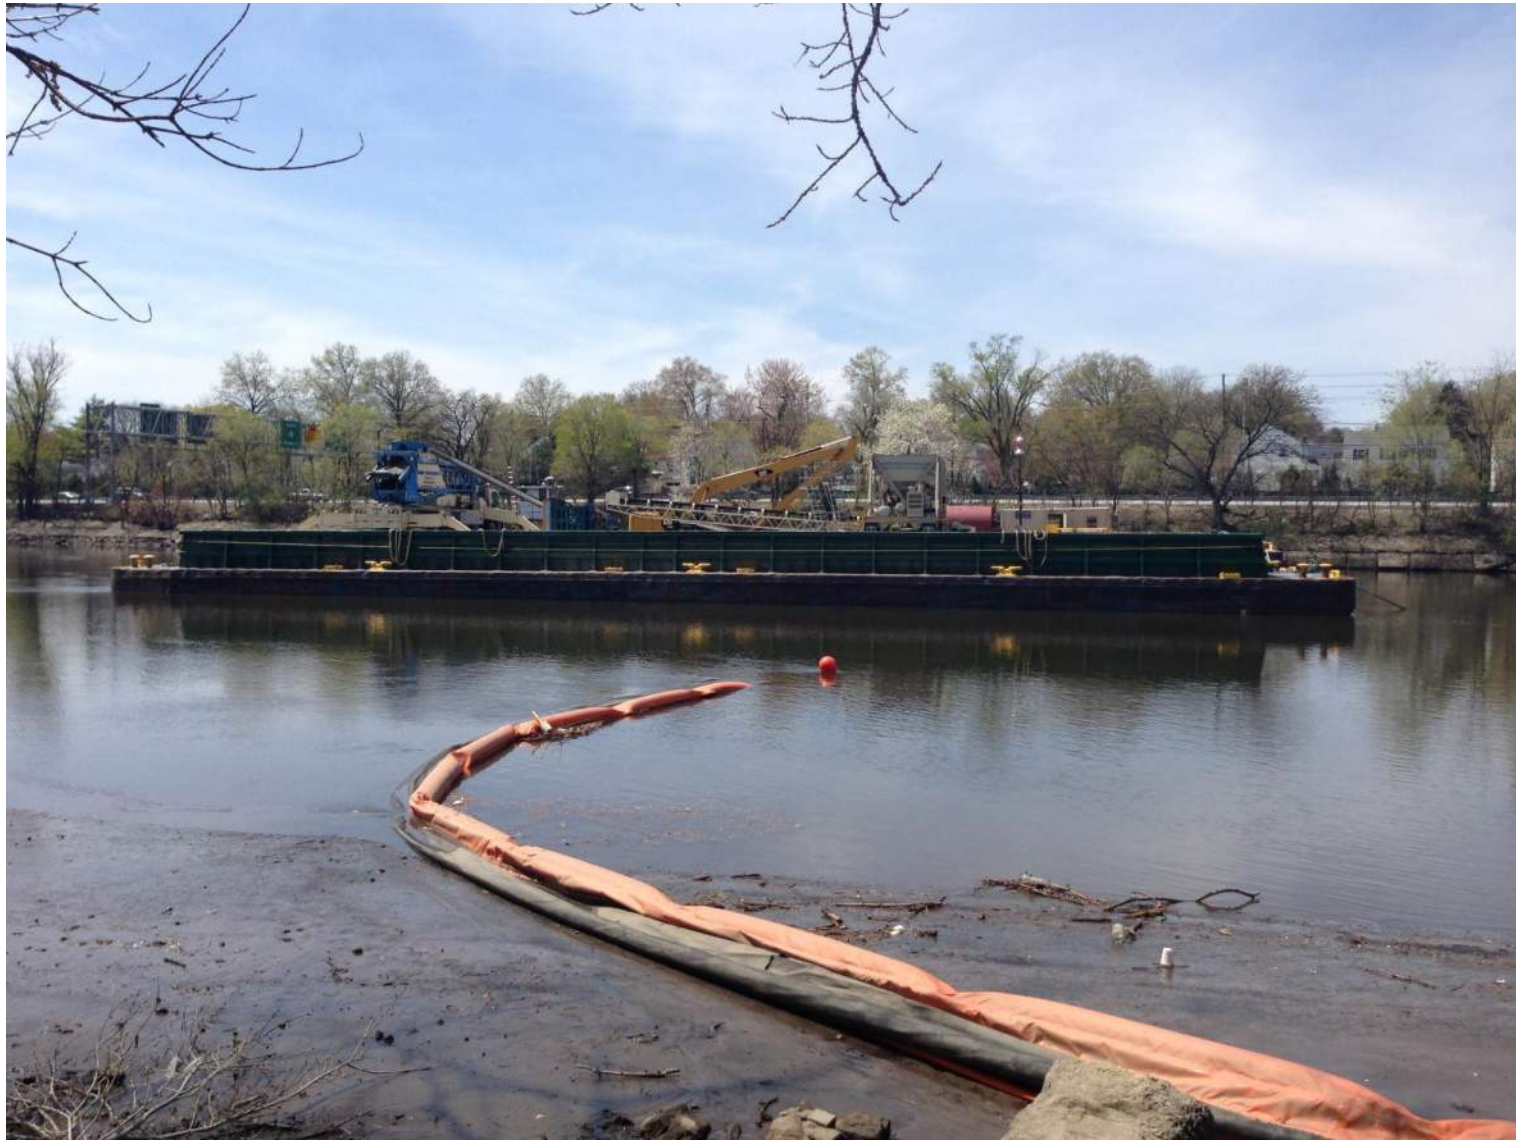
Telebelt at RM 10.9

The telebelt, which will be used for placement of the habitat layer, was observed at the southern edge of the capping area.

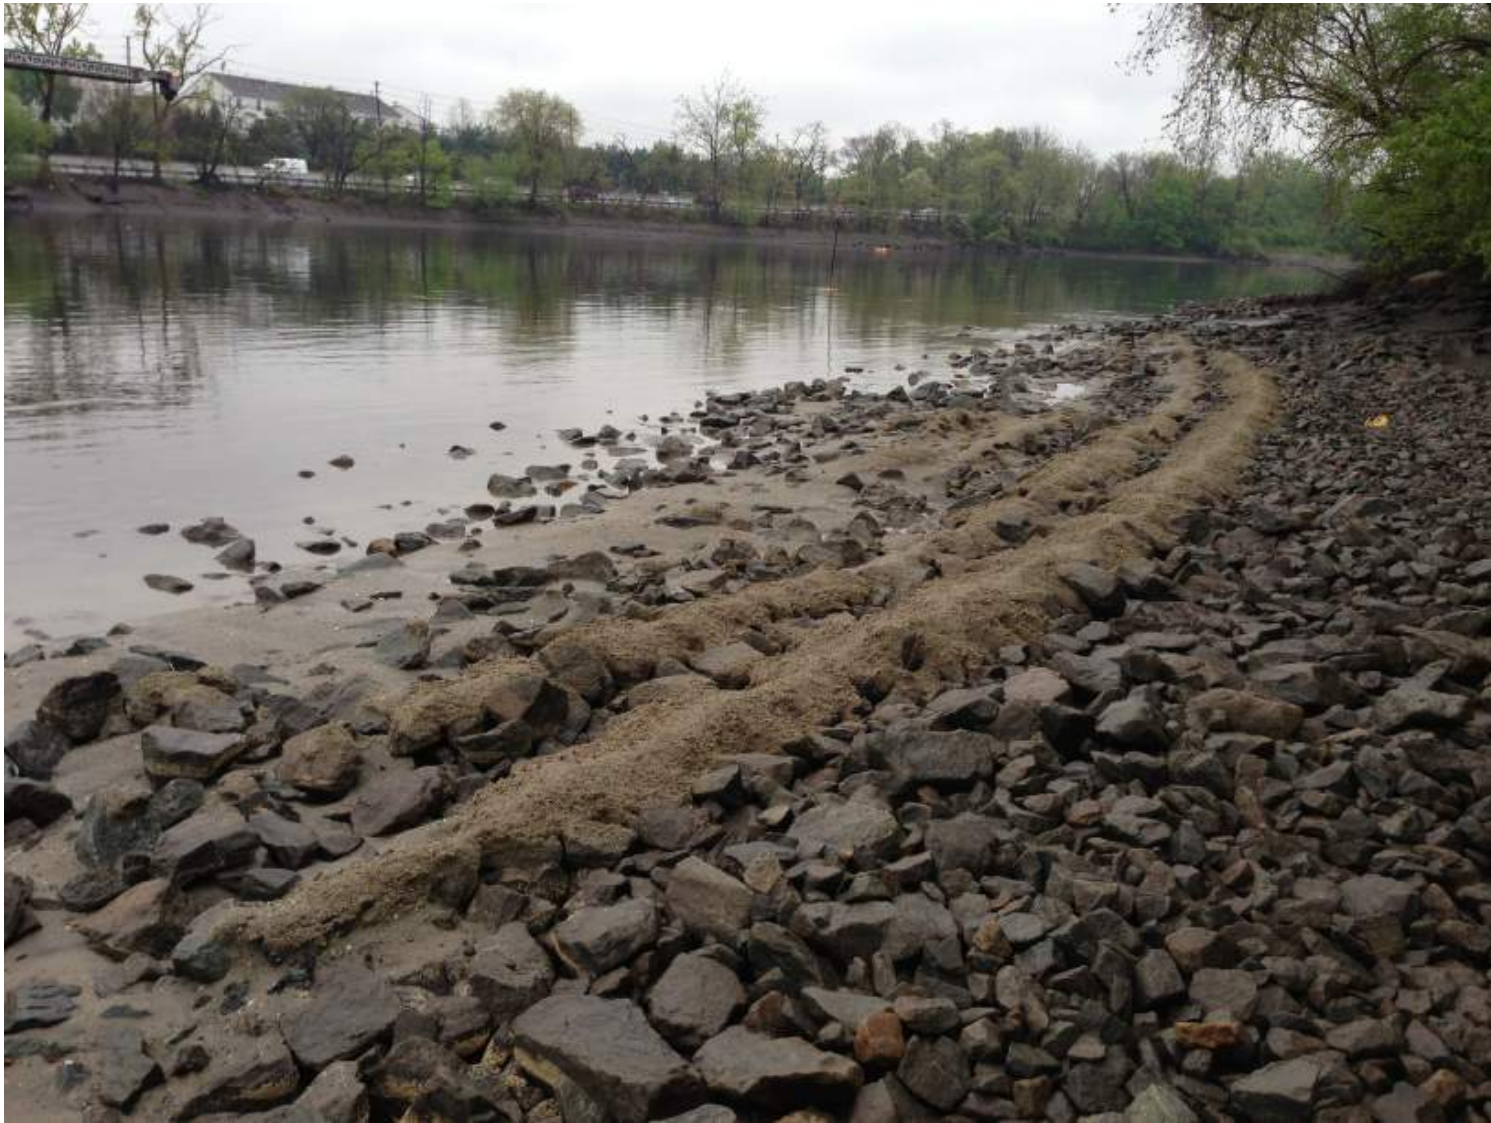
Habitat Layer after One Lift

The above photograph was taken after one pass of the telebelt. On the right there are two strips of sand sitting atop dry armor stone. On the left, the sand was placed in water (the tide subsequently went out) and settled more, which is why there is more visible armor stone.
